**Flood Control Project Maintenance
Levee Inspections**

Maintenance Issue Types Only, Levee Inspection Report By Mile - Fall 2016

Eastern Honcut Creek

Waterway	Bank	Unit Miles	Inspection Start/End	Inspector
Unit No. 01 Van Tress	Left	1.46	10/05/2016 10/05/2016	Sterling York

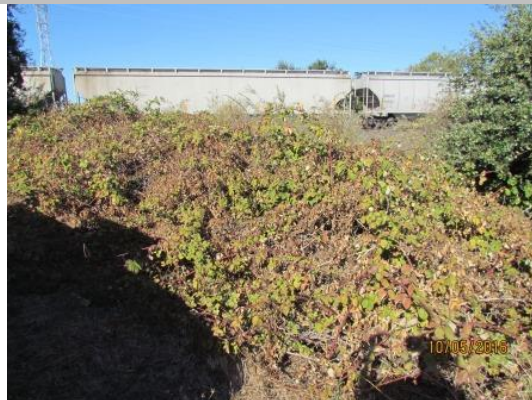
Photo 1 of 1 : FA_2016_NA0006_252_19_20161005_00024.jpg

LM Start	0.02	Rating **	U	Issue No.	19
LM End	0.02	Issue Type +	Ma	Location *	WS
Category	Earthen Levee			GPS Latitude/Longitude	
				Start	End
Item	Vegetation			39.298500°	39.298500°
				-121.569508°	-121.569508°
DWR ID	DWR_NA0006_01_f_2016_19				
Comment Code					
V2 : Remove the wild growth other than native grasses from the levee slopes.					
Inspector Comment					
Remove Blackberry bushes covering waterside levee slope.

View of Blackberry bushes covering waterside levee slope.

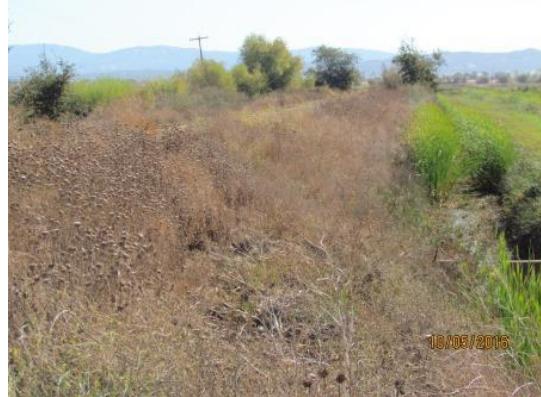
Photo 1 of 2 : FA_2016_NA0006_252_12_20161005_00029.jpg

LM Start	0.02	Rating **	M	Issue No.	12
LM End	1.45	Issue Type +	Ma	Location *	LS
Category	Earthen Levee			GPS Latitude/Longitude	
				Start	End
Item	Vegetation			39.298508 °	39.295263 °
				-121.569507 °	-121.546580 °
DWR ID	DWR_NA0006_01_f _ 2016_12				
Comment Code					
V1 : Control annual grass and weeds on the levee slopes and easements.					
Inspector Comment					
Annual vegetation needs to be maintained. Fall 2016.

View looking upstream landside of annual vegetation that needs to be maintained. Fall 2016.

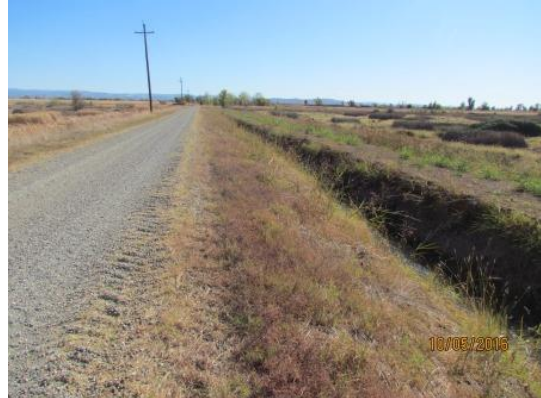
Photo 2 of 2 : FA_2016_NA0006_252_12_20161005_00030.jpg

Second view looking upstream landside of annual vegetation that needs to be maintained. Fall 2016.

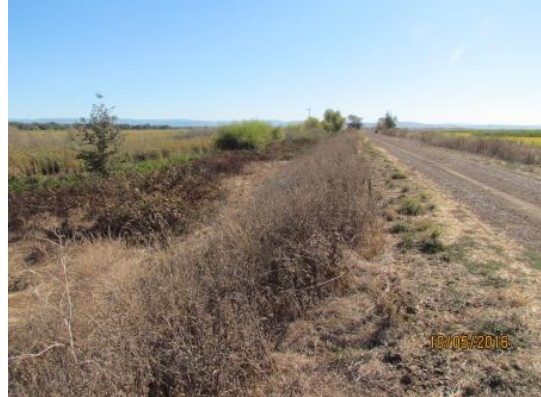
Photo 1 of 2 : FA_2016_NA0006_252_18_20161005_00031.jpg

LM Start	0.02	Rating **	M	Issue No.	18
LM End	1.45	Issue Type +	Ma	Location *	WS
Category	Earthen Levee			GPS Latitude/Longitude	
				Start	End
Item	Vegetation			39.298509 °	39.295263 °
				-121.569507 °	-121.546580 °
DWR ID	DWR_NA0006_01_f_2016_18				
Comment Code					
V1 : Control annual grass and weeds on the levee slopes and easements.					
Inspector Comment

View looking upstream waterside of annual vegetation that needs to be maintained. Fall 2016.

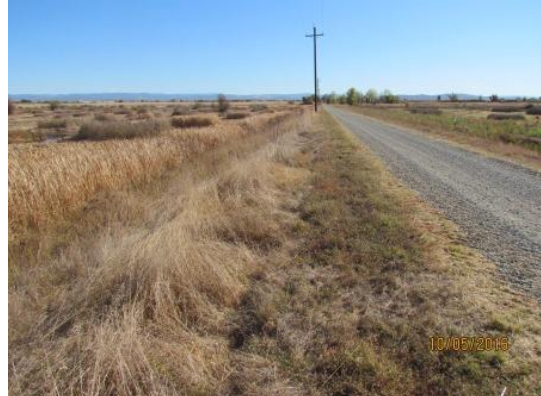
Photo 2 of 2 : FA_2016_NA0006_252_18_20161005_00032.jpg

Second view looking upstream waterside of annual vegetation that needs to be maintained. Fall 2016.

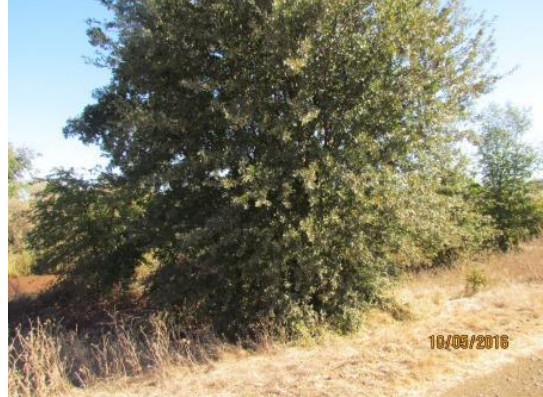
Photo 1 of 1 : FA_2016_NA0006_252_22_20161005_00026.jpg

LM Start	0.10	Rating **	M	Issue No.	22
LM End	0.10	Issue Type +	Ma	Location *	WS
Category	Earthen Levee			GPS Latitude/Longitude	
				Start	End
Item	Trim / Thin Trees			39.299078 °	39.299078 °
				-121.568633 °	-121.568633 °
DWR ID	DWR_NA0006_01_f _ 2016_22				
Comment Code					
T1 : Trim trees to at least five feet above ground level.					
Inspector Comment					
A tree that needs the limbs trimmed up 5' for visibility and access on the waterside. Fall 2016.

View of a tree that needs the limbs trimmed up 5' for visibility and access on the waterside. Fall 2016.

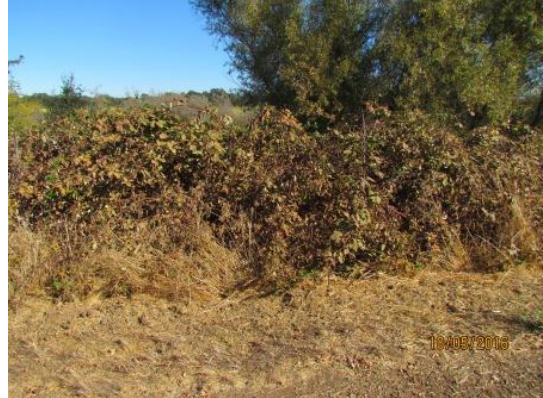
Photo 1 of 1 : FA_2016_NA0006_252_24_20161005_00034.jpg

LM Start	0.21	Rating **	U	Issue No.	24
LM End	0.24	Issue Type +	Ma	Location *	WS
Category	Earthen Levee			GPS Latitude/Longitude	
				Start	End
Item	Vegetation			39.298836 °	39.298768 °
				-121.566572 °	-121.565921 °
DWR ID	DWR_NA0006_01_f_2016_24				
Comment Code					
V2 : Remove the wild growth other than native grasses from the levee slopes.					
Inspector Comment					
Remove Blackberry bushes covering the waterside slope.

View of Blackberry bushes that cover the waterside slope. Fall 2016.

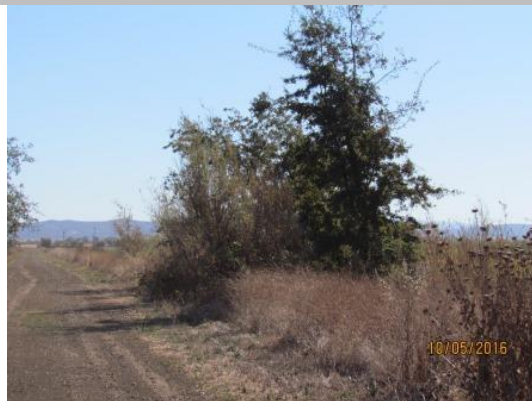
Photo 1 of 1 : FA_2016_NA0006_252_23_20161005_00027.jpg

LM Start	0.21	Rating **	U	Issue No.	23
LM End	0.21	Issue Type +	Ma	Location *	LS
Category	Earthen Levee			GPS Latitude/Longitude	
				Start	End
Item	Trim / Thin Trees			39.298816 °	39.298816 °
				-121.566529 °	-121.566529 °
DWR ID	DWR_NA0006_01_f_2016_23				
Comment Code					
T3 : Trim and thin trees to allow visibility of the ground and room to flood fight.					
Inspector Comment					
Trees that needs the limbs trimmed up 5' for visibility and access on the landside. Fall 2016.

View of trees that needs the limbs trimmed up 5' for visibility and access on the landside. Fall 2016.

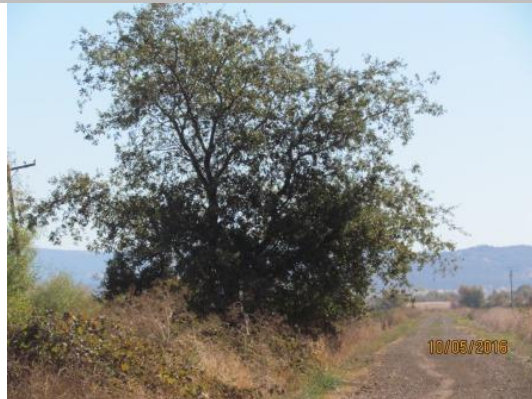
Photo 1 of 1 : FA_2016_NA0006_252_25_20161005_00028.jpg

LM Start	0.23	Rating **	M	Issue No.	25
LM End	0.23	Issue Type +	Ma	Location *	WS
Category	Earthen Levee			GPS Latitude/Longitude	
				Start	End
Item	Trim / Thin Trees			39.298776°	39.298776°
				-121.566158°	-121.566158°
DWR ID	DWR_NA0006_01_f_2016_25				
Comment Code					
T1 : Trim trees to at least five feet above ground level.					
Inspector Comment					
Tree that needs the limbs trimmed up 5' for visibility and access on the waterside. Fall 2016.

View of a tree that needs the limbs trimmed up 5' for visibility and access on the waterside. Fall 2016.

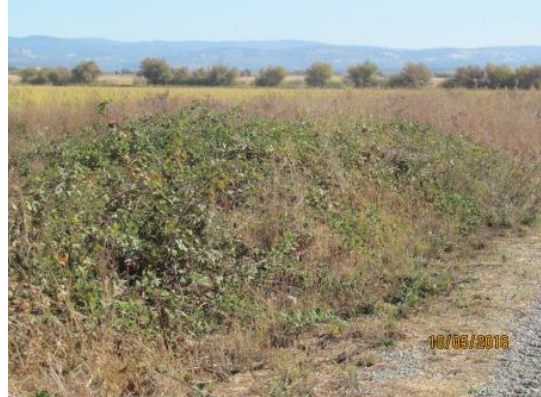
Photo 1 of 1 : FA_2016_NA0006_252_1_20161005_00037.jpg

LM Start	0.85	Rating **	M	Issue No.	1
LM End	0.96	Issue Type +	Ma	Location *	WS
Category	Earthen Levee			GPS Latitude/Longitude	
				Start	End
Item	Vegetation			39.294995 °	39.295021 °
				-121.557823 °	-121.555813 °
DWR ID	DWR_NA0006_01_f _ 2016_1				
Comment Code					
V2 : Remove the wild growth other than native grasses from the levee slopes.					
Inspector Comment					
Remove Blackberry bushes starting to take over waterside slope.

View of Blackberry bushes that are starting to cover the waterside slope. Looking upstream. Fall 2016.
